M/EB 453/63
22 October 1963
Copy 2

SUBJECT: Soviet Suspect Solid Propellant Test Facilities, USSR

2. Significant Observations - Sterlitamak (53-44N 56-00E)

5. Significant Observations - Krasnoyarsk (56-02N 93-02E)

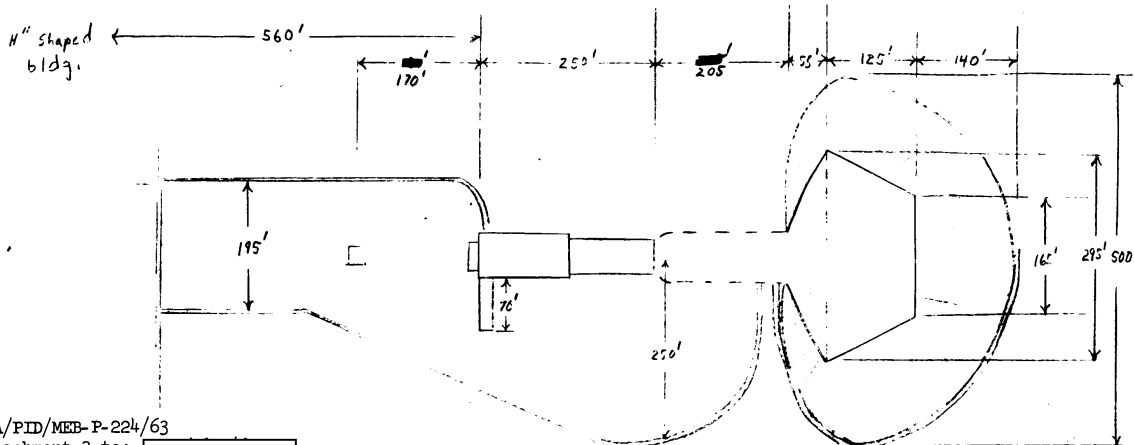
CIA/PID/MEB-P-224/63

(2) The test cell is not revetted or mounded at the Sterlitamak facility and appeared essentially complete in []. The cell is road served at the end which faces a probable bunker/deflector approximately 260 feet away. The road is of a wide turn radius nature. 25X1

A - Probable Test Cell

(3) The probable bunker/deflector can be observed in []. However, a concrete facing (later its most revealing trait), cannot be observed in [] and cannot be confirmed until []. Though the concrete facing suggests a deflector role, a road serving the rear of the probable bunker/deflector leads to the possibility of an instrumentation role, also. Measurements of the probable bunker/deflector should be considered relatively unreliable due to an extreme distortion of high images. 25X1

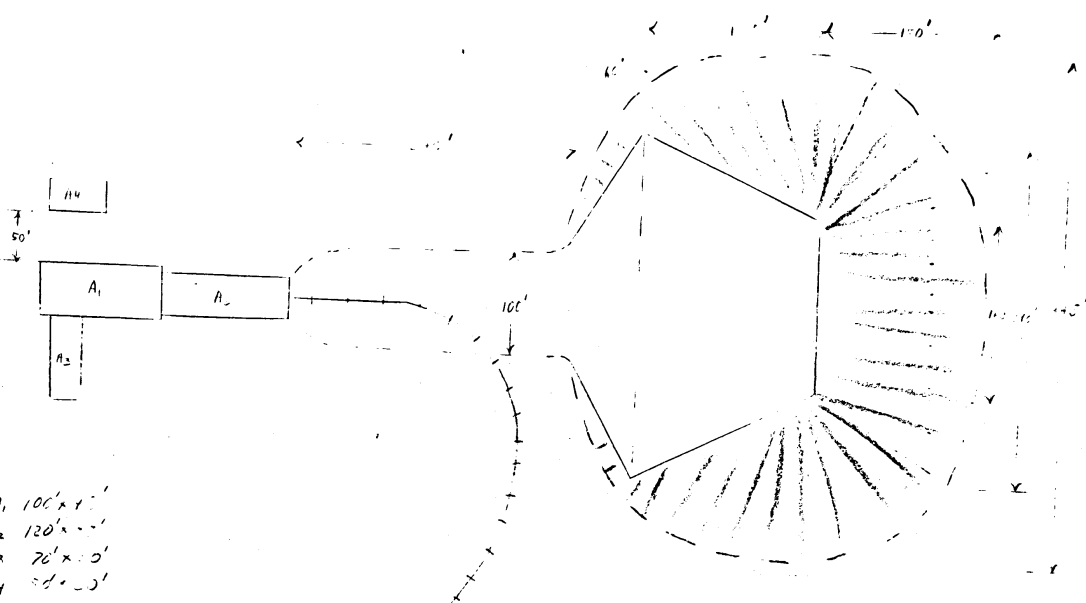
CIA/PID/MEB-P-225/63

c. The test cell at the Perm facility is rail served at the end which is closest to the probable bunker/deflector. The probable bunker/deflector is approximately 250 feet from the end of the test cell.

- A1 100' x 100'
- A2 120' x 100'
- A3 70' x 100'
- A4 20' x 100'

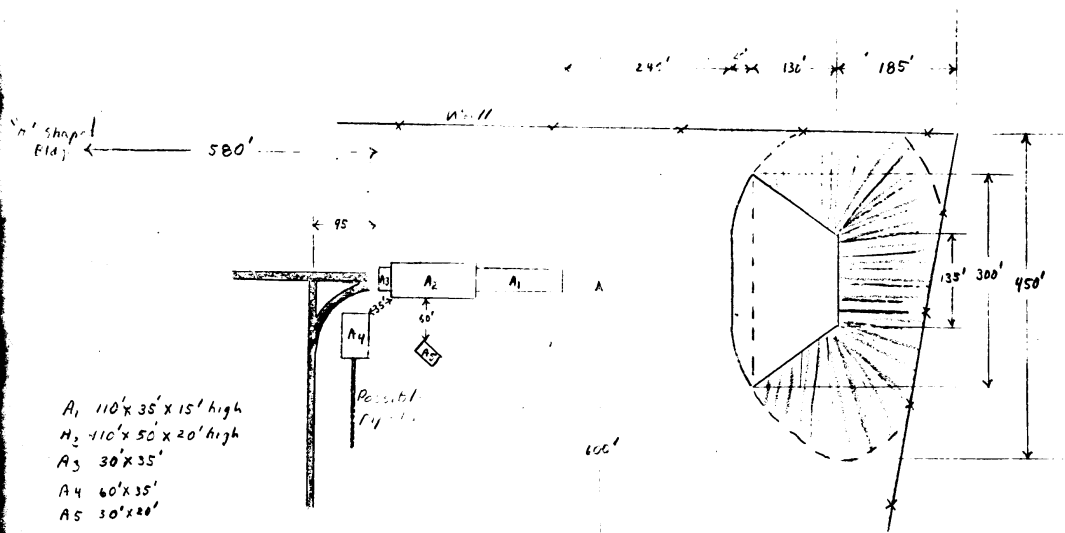
CIA/PID/MEB-P-227/63

(2) The facility has two test cells which are annotated A and B.
25X1 Test Cell A was first discernible in [redacted] It appeared to be essentially complete at that time. Overhead piping or covered walkways connect Test Cell A to a revetted building approximately 300 feet away. The front edge of the test cell faces a probable bunker/deflector approximately 240 feet away.

(3) Test Cell B, the older of the two cells, appeared essentially
25X1 complete in [redacted] Cell B is also connected to the same revetted building the Cell A is. Again the connection is made by overhead piping or covered walkways. The front end of Cell B is approximately 75 feet from the 45 feet high probable bunker/deflector which serves it.

(4) The probable bunker/deflector serving Test Cell A is at least
60 feet high. It was first discernible as being under construction in [redacted] However, confirmation of its completion cannot be made until [redacted] when
25X1 its concrete facing (the most easily identifiable feature at all five suspect facilities) is apparent. The probable bunker/deflector serving Test Cell B was complete (with concrete facing) in [redacted] Though a deflector role is suggested in each case by the concrete facing, no final judgement of this function can be made. There is little or no suggestion that the probable bunker/deflector is served to the rear by any road or trail.

f. A final observation at the Krasnoyarsk facility is some scarring which is noted to the front of Test Cell A in [redacted] Though the funnel shape of this scar suggests the possibility of a blast mark, it is the opinion of the photo analysts that no conclusive statement can be made on the basis of the photography available
